APPENDIX D

Minor Projects PA Project Submittal and Assessment Form

Project Designation Number: 2001922

Route Number: State Road (SR) 65

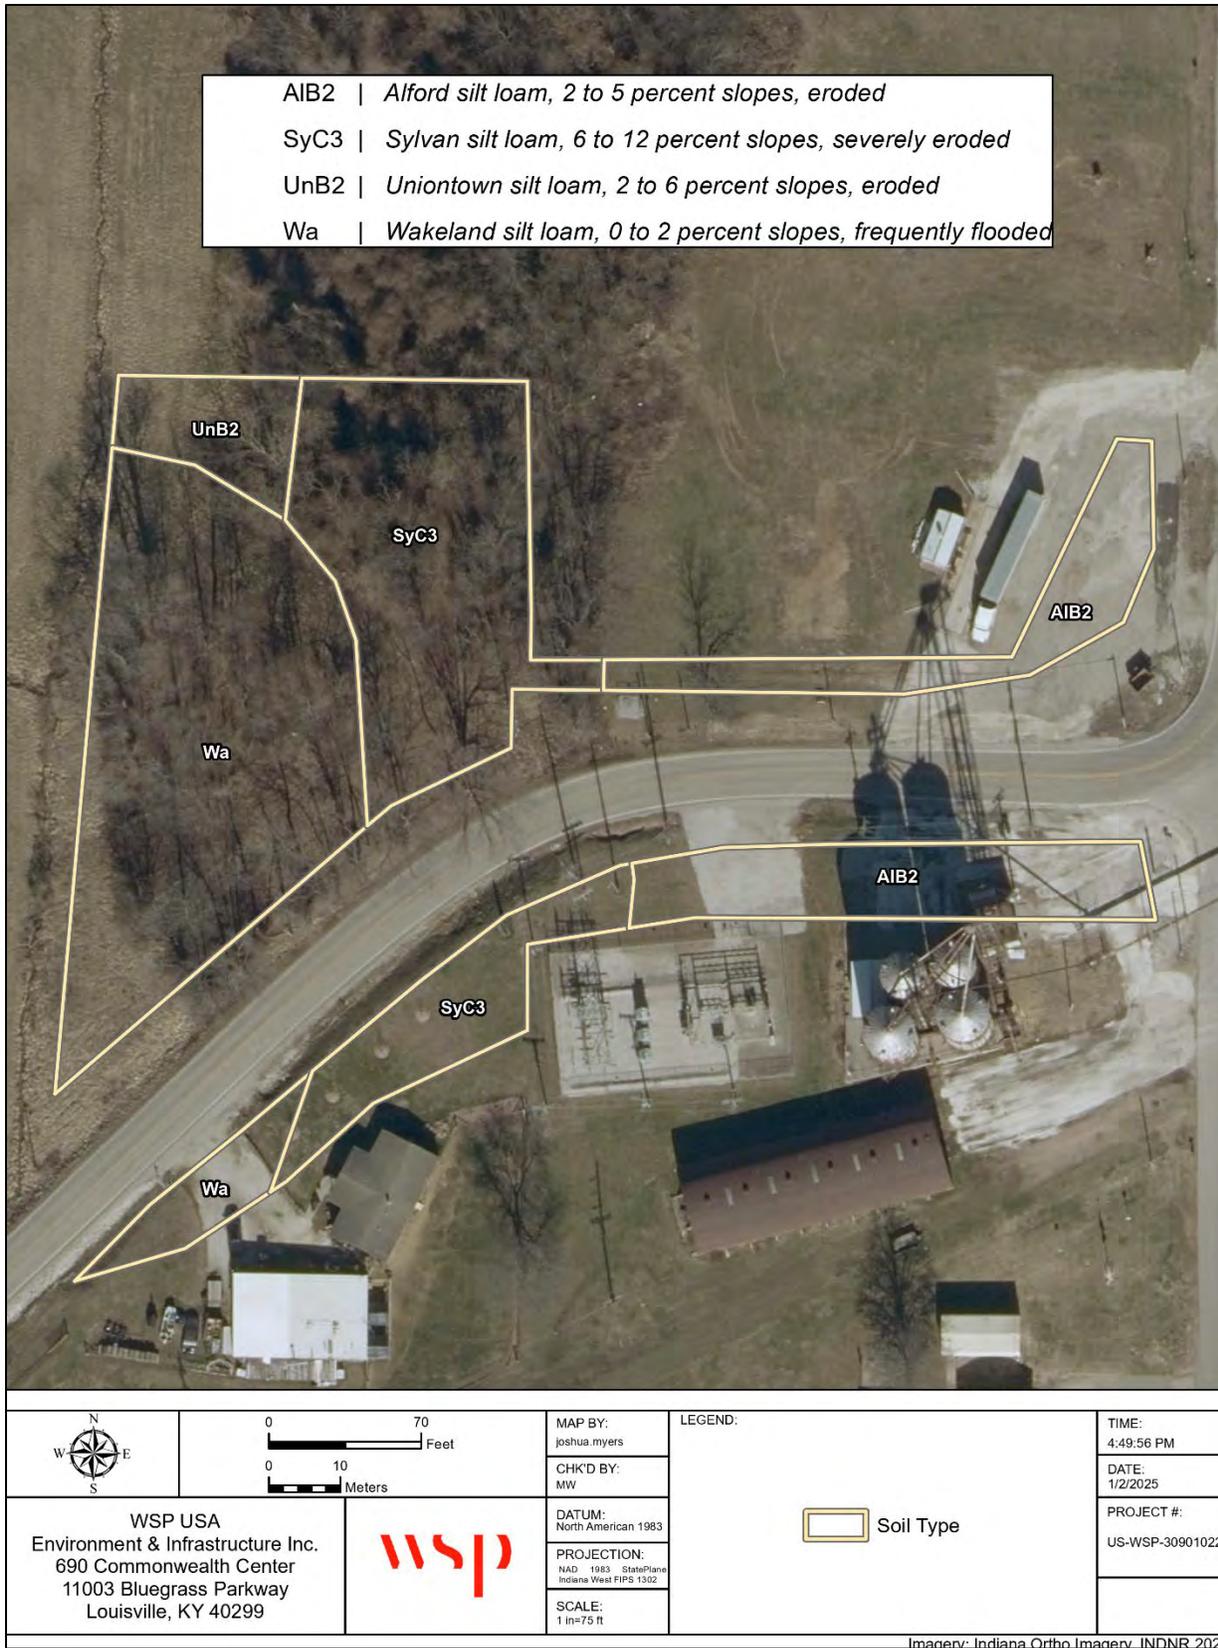
Figure 2.2. Soil types within the 2025 survey area (INDOT Des. No 2001922).

Table 2.1. Summary of Soil Types Found within the survey area.

Soil Type	Typical Soil Profile	Drainage	Parent Material	Landform
Alford silt loam, 2 to 5 percent slopes, eroded (AIB2)	silt loam (Ap) - silty clay loam (Bt1) - silt loam (Bt2) - silt loam (2BC)	Well drained	Loess over gritty loess	Loess hills
Sylvan silt loam, 6 to 12 percent slopes, severely eroded (SyC3)	silt loam (Ap) - silt loam (Bt) - silt (C)	Well drained	Loess	Loess hills
Uniontown silt loam, 2 to 6 percent slopes, eroded (UnB2)	silt loam (Ap) - silty clay loam (Bt) - silt loam (BCt) - silt (C)	Well drained	Silty lacustrine deposits	Lake terraces
Wakeland silt loam, 0 to 2 percent slopes, frequently flooded (Wa)	silt loam (Ap) - silt loam (Cg1) - silt loam (Cg2) - silt loam (Cg3)	Somewhat poorly drained	Silty alluvium	Flood plains

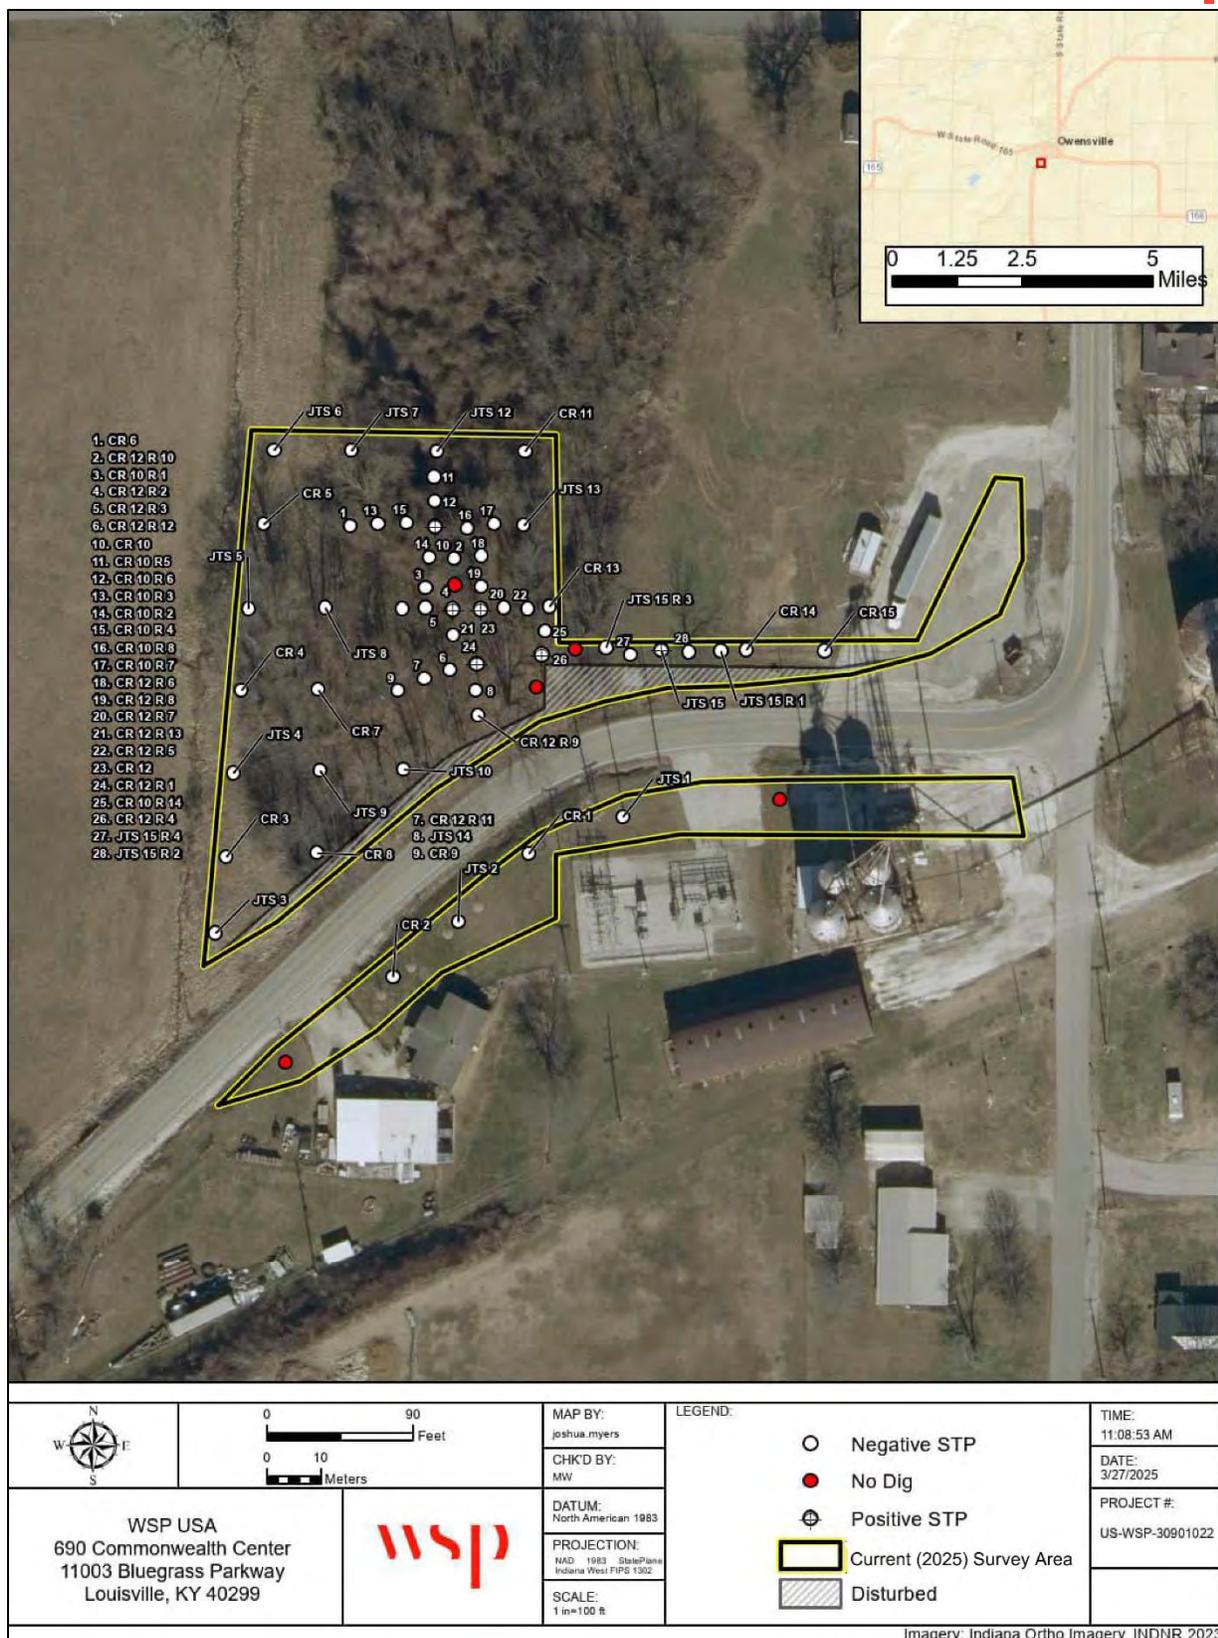
Figure 5.1. A 2023 aerial map of the survey area (INDOT Des. No 2001922) showing survey results (IN IGIO 2023).

As a result of this survey, one newly recorded archaeological site (12Gi1713) was identified. Site 12Gi1713 consists of a scatter of historic architectural material dating from the mid-nineteenth to early twentieth century. Further discussion of the site can be found below in **Chapter 6** of this report.
